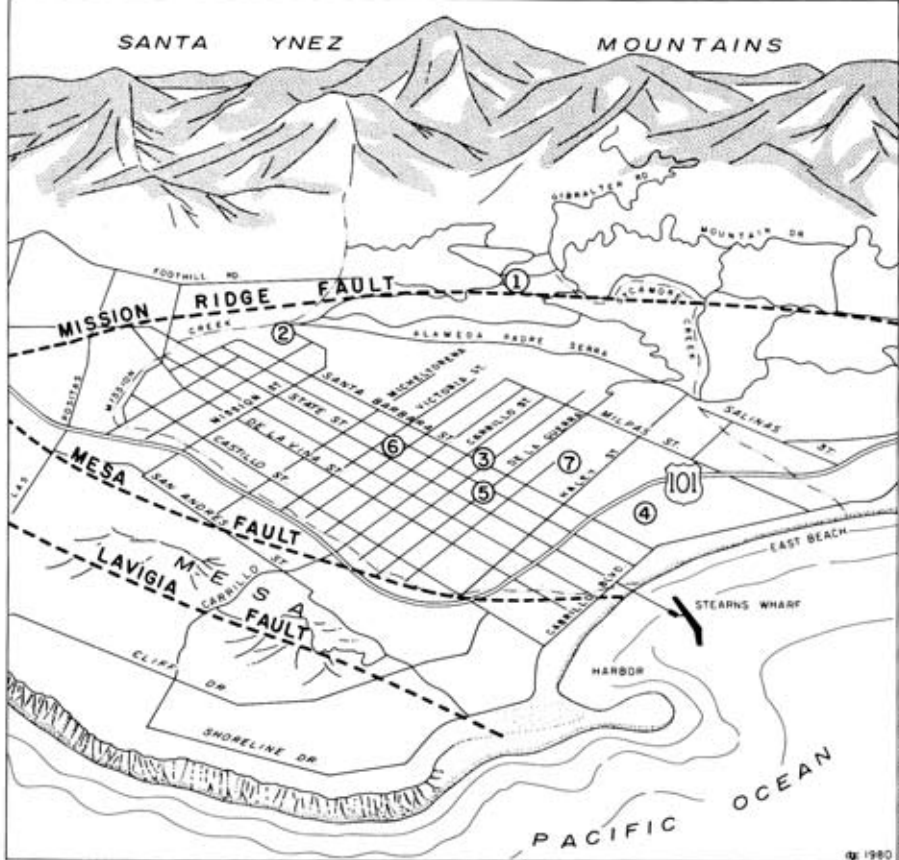
Above: This schematic index map of Santa Barbara's faults shows Sheffield Reservoir (1), Santa Barbara Mission (2), the presidio (3), El Estero Waste Water Treatment Plant (4), Santa Barbara City Hall (5), the Granada Building (6), and the Laguna Park area (7). All faults, valleys, and mountains trend east and west, in contrast to California's prevailing northwest and southeast structural grain.
